S92 Frequently Asked Questions

Recently, Sikorsky, the manufacturer of the S-92 helicopter, issued a letter to all operators concerning some occurrences of cracking which had been detected in one of the four feet which mount the S-92 Main Gearbox to the aircraft.

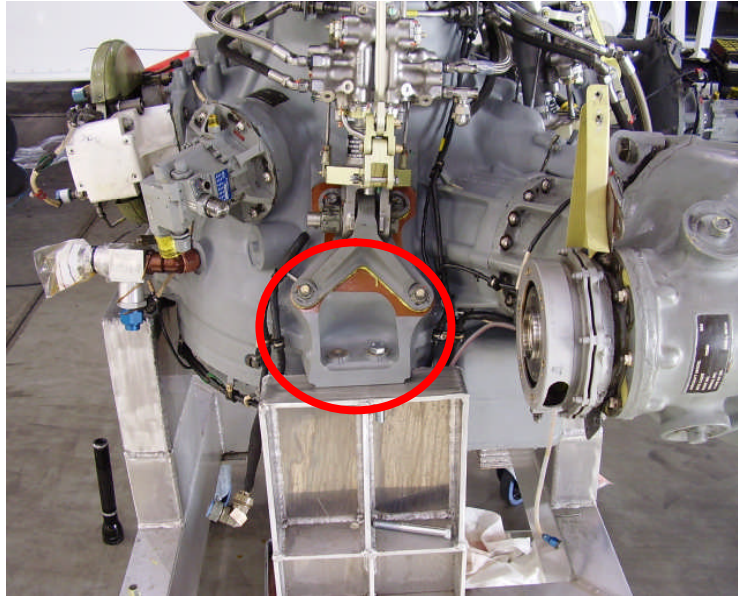
Picture 1 – S92 Main Transmission (entire foot circled)

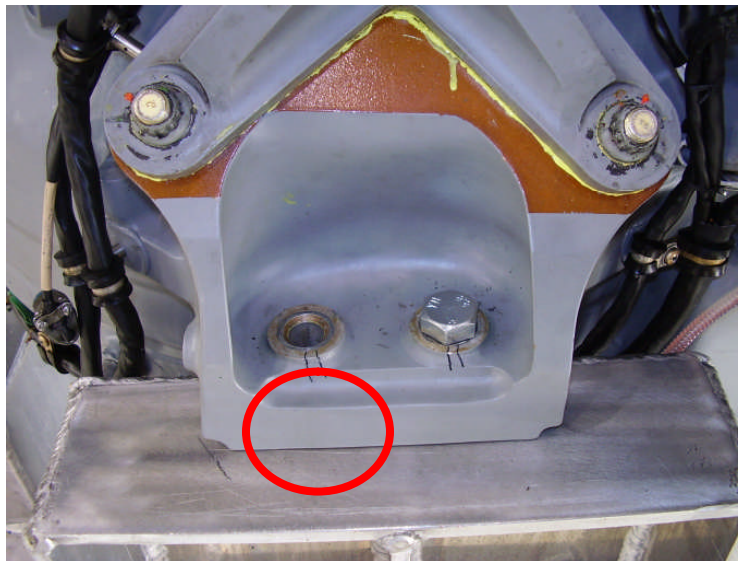
Picture 2 – Close up of Main Transmission Foot (area of defect circled)

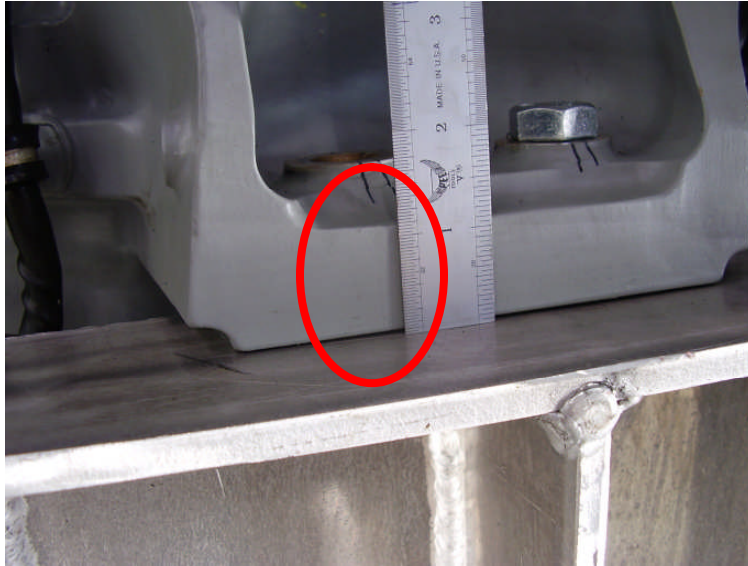
The gearbox feet are inspected every 10 flight hours in accordance with ASB92-63-020. Cracks are first identified visually and then confirmed with an NDT test.

Picture 3 – Hairline crack just visible, length circa one inch

ASB92-63-020 requires a visual inspection. Bristow is carrying out an Eddy Current NDT test as additional verification if a crack is suspected.

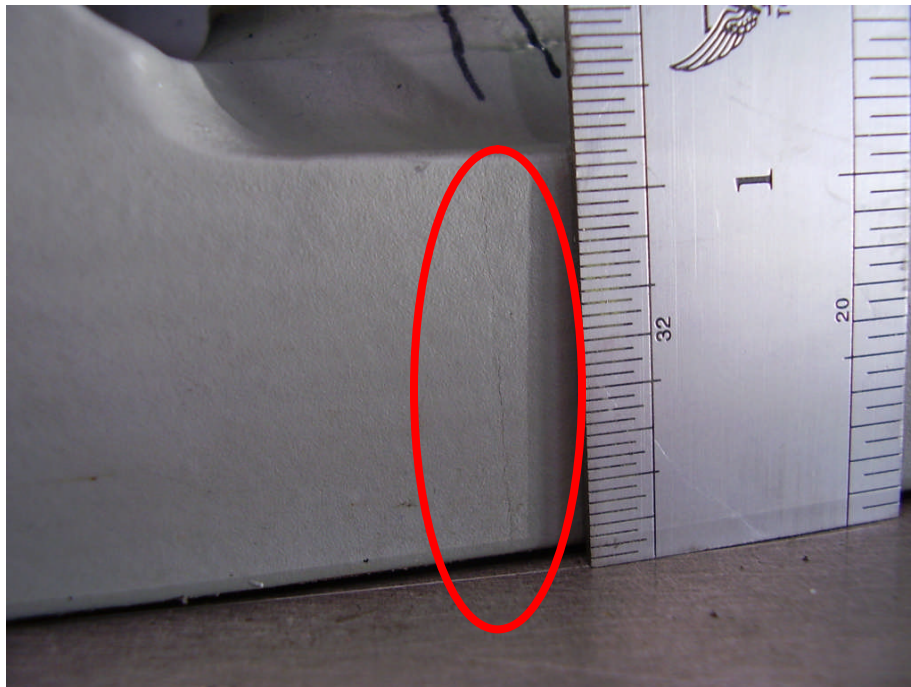
Picture 4 – High magnification shot of defect
